KUKEN Product Maintenance Standards		SPEC.No.
		Enacted on:1-11-1990
		Issued on:
Symptom of malfunction / Checking Point		Ref Page
No motor rotates	(1) <u>When the anvil does not rotate by hand, the clutch unit is damaged.</u> Remove the bolts tightening the clutch case and check the clutch unit.	P-3

Type N Impact Wrench
Operating Limit Size (1)

KUKEN Product Maintenance Standards	SPEC NO.
	Type N Impact Wrench	Enacted on:
	Handle and clutch Units: Repair & Check Procedure	Issued on:

KUKEN Product Maintenance Standards		SPEC NO.
Type N Impact Wrench Motor Unit: Repair and Checking Procedure		Enacted on.
		Issued on.
<p>Faults at motor unit:</p> <ol style="list-style-type: none"> (1) Rotor and end plate seizure (2) Broken rotor spline shaft (3) Blade damage (4) Clogged incoming air path (5) Rusting (6) Ingress of foreign matter into motor (7) Misassembly (For example, failure to insert the blade and incorrect positioning of cylinder and end plate.) 		
Motor Parts Checking Items	Countermeasure	
<p>(1) End plate</p> <ul style="list-style-type: none"> -Poor flatness -Seizure with rotor -Rusting

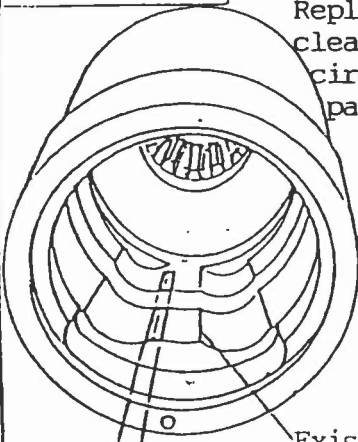
HAMMER WHEEL

Simple re-usability check method:
Replacement is required if a
clearance exists when the outer
circumferential grinding finish
part of anvil piece is pressed.

Judgement by calipers
Existence of sharp part(Reusable)

Replacement Standards	
TYPE	WIDTH
KW-1600	1.0Min.
2000	1.0Min.
2500	1.0Min.
3800	1.5Min.
4500	1.5Min.
5000	1.5Min.

(1) Cam-----Wear or damage	
(2) Anvil-----Wear or damage	
(3) Anvil piece-----Wear or damage	Correct or replace
(4) Hammer Wheel-----Wear or damage	(Refer to the following when checking)
(5) Plungers A,B-----Wear	
(6) Main Spring-----Permanent set in fatigue or damage	Type N Impact Wrench Clutch Parts
(7) Washer-----Wear	Operating limit size(1)(2)
(8) Retainer-----Damage	New/Old shape comparison Table
(9) Clutch case c.p.-----Deformation	Correct or replace
Loose case bushing	Correct or replace
Grease leakage(O-ring)	Replace O-ring
(10) Each O-ring-----Wear or breakage	Replace

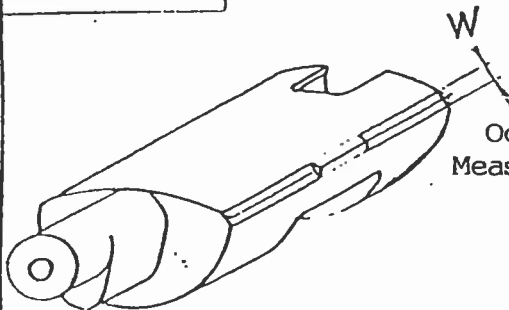
ANVIL PIECE

Occurring on the plane
Measure with calipers

Replacement Standards	
TYPE	WIDTH
KW-1600	0.7Min.
2000	0.7Min.
2500	0.7Min.
3800	1.0Min.
4500	1.0Min.
5000	1.0Min.

- (1) Replace the spring if the end turn is damaged.
- (2) When replacing the anvil piece with a new one, also replace the main spring at the same time.

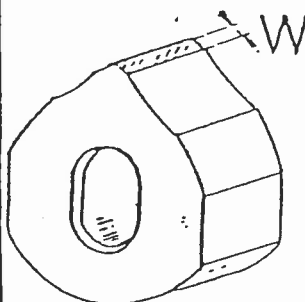
Cam

W: Measure the width on the plane due to wear with calipers.

Type	Width
KW-1600	0.7Min
2000	1.0Min
2500	1.0Min
3800	1.5Min
4500	1.8Min
5000	2.0Min

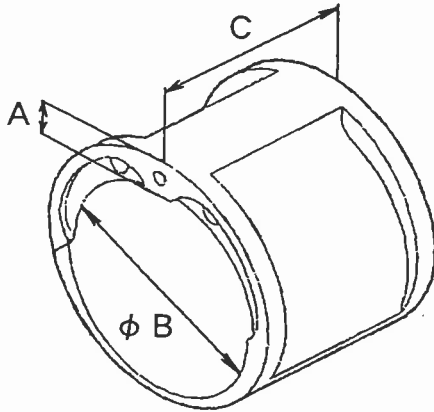
N型 (N-TYPE)

(株) 空研 製品保守基準
 KUKEN Co., Ltd. Repair Limits
 インパクトレンチ (シリンダ)
 IMPACT WRENCH (CYLINDER)

- 1.よく洗浄して注意深く確認してください。
 Make sure that any deformation is not observed.
- 2.接触する部品の摩耗にも注意を払ってください。
 Keep your attention to connected parts are worn away.

<p>Re-set Replace Correct or Replace Replace</p>
<p>(3) Cylinder</p> <ul style="list-style-type: none"> -Interior wear and damage -Entire length is too short -Rusting 		<p>Correct or replace Replace Correct or replace</p>

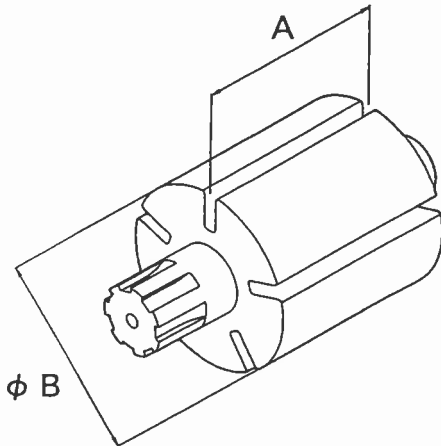
N型 (N-TYPE)

(株) 空 研 製品保守基準
 KUKEN Co., Ltd. Repair Limits
 インパクトレンチ (ロータ)
 IMPACT WRENCH (ROTOR)

Make sure that any deformation is not observed.

Keep your attention to connected parts are worn away.

</p>	<p>Correct or replace Correct or replace Replace</p>
<p>(2) Rotor</p> <ul style="list-style-type: none"> -Poor setting -Spline shaft broken -Rusting <p>-Shell length is too short (Due to repeated repair)</p>

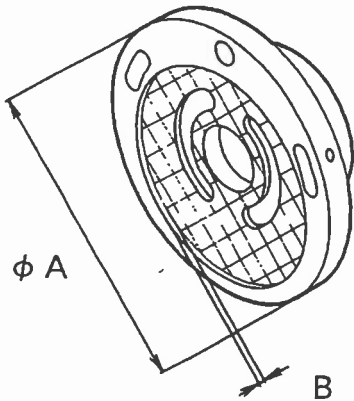
N型 (N-TYPE)

(株)空研 製品保守基準
 KUKEN Co., Ltd. Repair Limits
 インパクトレンチ (上エンドプレート)
 IMPACT WRENCH (REAR PLATE)

Make sure that any deformation is not observed.

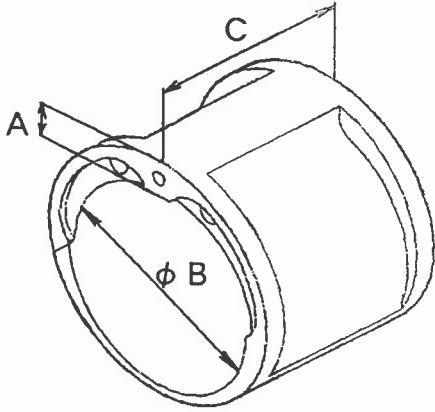
KW-385G	KW-420G	
シリンダ Cylinder

Please replace the parts, in case of the worn size are more than limits.

A	基準 Standard	14.5	16.5
		限界 Limit	14.480	16.480
	B	基準 Standard	72.8	80
		限界 Limit	—	—
	C	基準 Standard	55	65
		限界 Limit	54.990	64.990
ブレード Rotor Blade

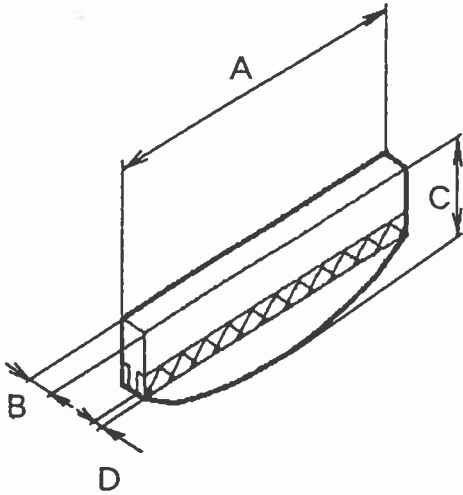
A	基準 Standard	55	65
		限界 Limit	54.80	64.80
	B	基準 Standard	5	5
		限界 Limit	4.5	4.5
	C	基準 Standard	21	24
		限界 Limit	20.5	23.5
	D	基準 Standard	0	0
		限界 Limit	0.1	0.1

よく洗浄して注意深く確認して下さい

<p>(4) Blade</p> <ul style="list-style-type: none"> -Wear(Side surface) -Faulty size -White blade(Contraction by overheat) -Brown blade(Expansion by moisture and overheat) -Damage -Failure to insert -Abnormal noise("boon" occurs)
